January 16, 2007
Montana Legislature
Joint Long-Range Planning Subcommittee
Hearing for HB11
DNRC Renewable Resource Grant and TSEP Project Funding

Justification for Providing Funding to the Town of Brady for Upgrading and Repairing the Wastewater Lagoon and Collection System

Brady Lagoon - Leakage Prevention from Cell #1 - 11/2/06

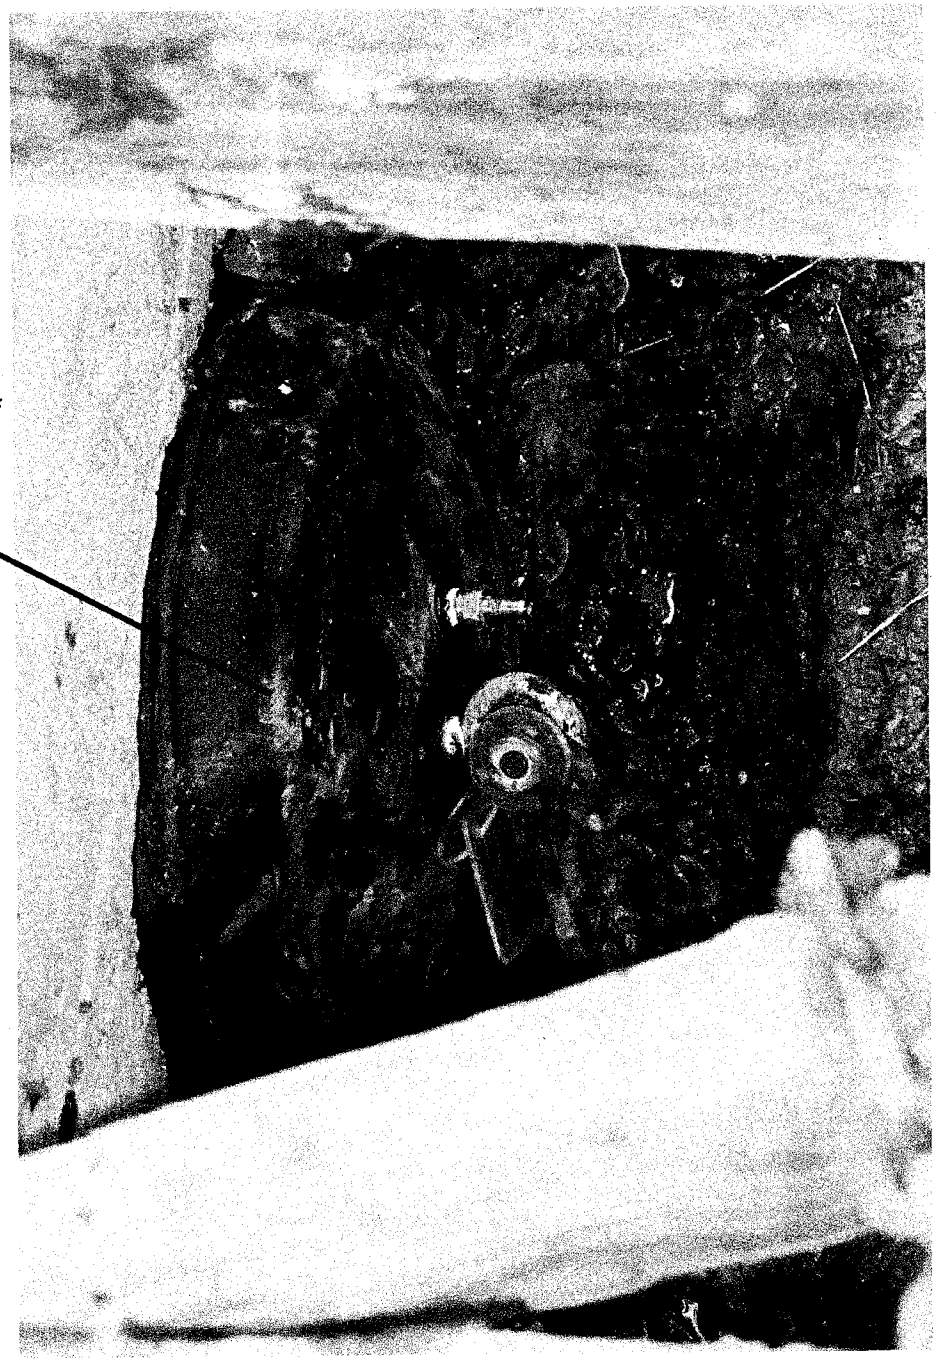
Lagoon side of boards water about 3" from top of bottom board. So, has 19" before water would go over boards. Flow beginning to transfer from cell #1 to cell #2.

The lagoon currently has lots of storage space in cells 1,2 and 3.

Pipe plug placed in discharge pipe 11/16/06 to ensure no discharge if boards begin leaking.
